CITY OF PHOENIX
PLANNING & DEVELOPMENT DEPARTMENT
HISTORIC PRESERVATION OFFICE

GUIDE TO WINDOW REPAIR & REPLACEMENT FOR HISTORIC PROPERTIES

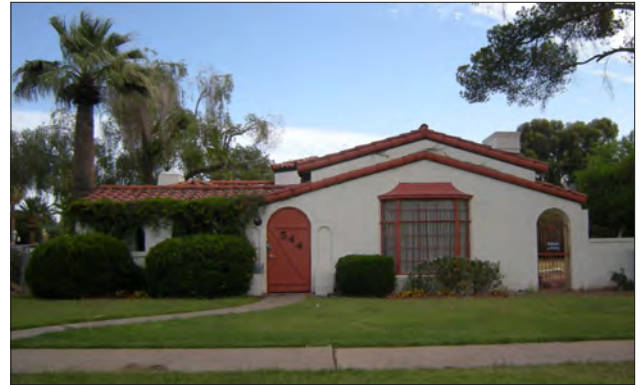
The front bay window of this historic house is a Tier 1 window and should be a high priority for preservation.

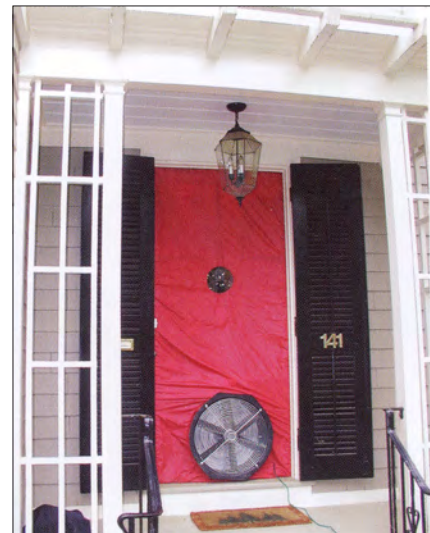
Energy auditors often use calibrated fans to measure the relative tightness of a building and to identify sources of air leaks.

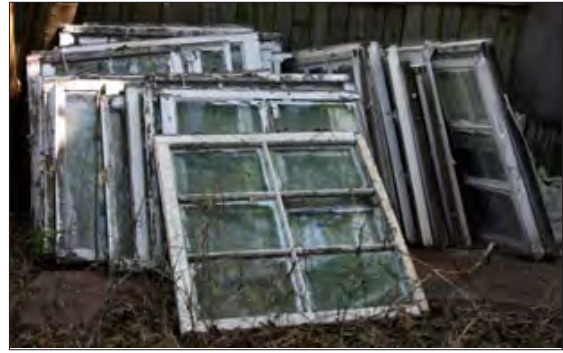
Removing repairable windows and dumping them in a landfill is contrary to “green” principles.

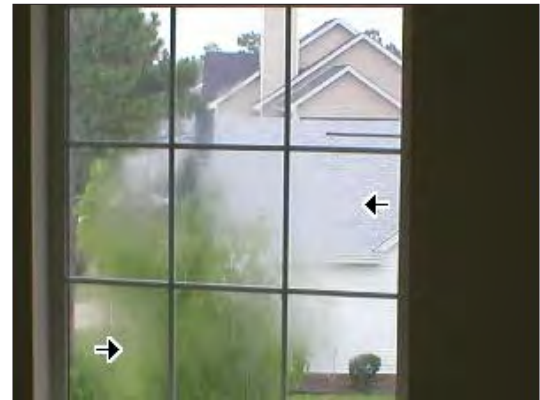
A common problem with dual-pane replacement windows is that the insulating seal will eventually leak and moisture will penetrate between the glass, leaving the window looking foggy. When this happens, the glass—or perhaps the entire window—will need to be replaced again.

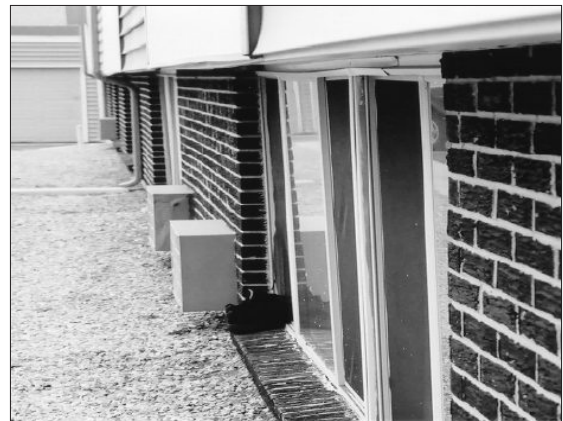
Vinyl window frames are constructed of polyvinyl chloride (PVC), a plastic material that breaks down in direct sunlight. To increase their longevity, vinyl frames include UV light stabilizers to keep them in good condition. However, over time, these windows may begin to lose their color, turn yellowish, or degrade. They are particularly susceptible to warping at high temperatures, as seen in the example above.

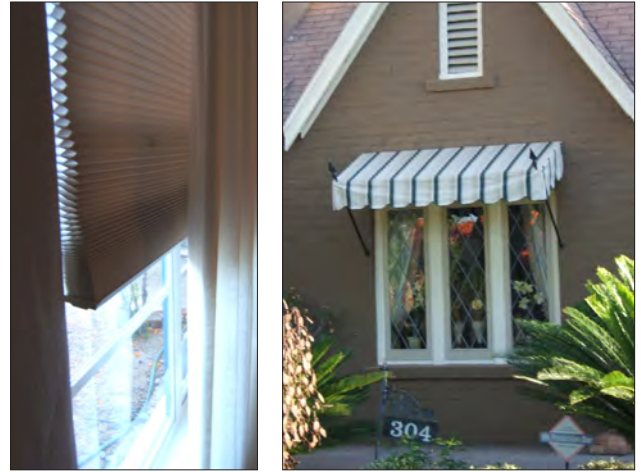
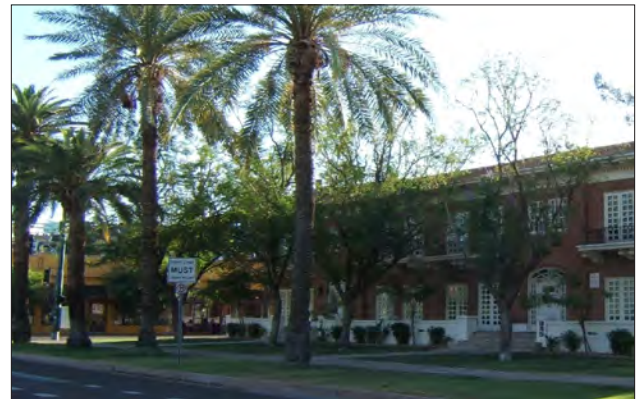
Heat gain/loss in historic windows can often be reduced through passive solutions such as adding insulated interior blinds (top left), exterior fabric awnings (top right), and strategically placed shade trees (bottom).

One cost-effective solution is to reduce heat gain/loss in remaining historic windows through passive improvements such as adding insulated interior blinds, exterior fabric awnings, and/or strategically placed shade trees (see examples at right). This approach can greatly improve the building’s overall performance while still retaining the unique historic aesthetics of the property.

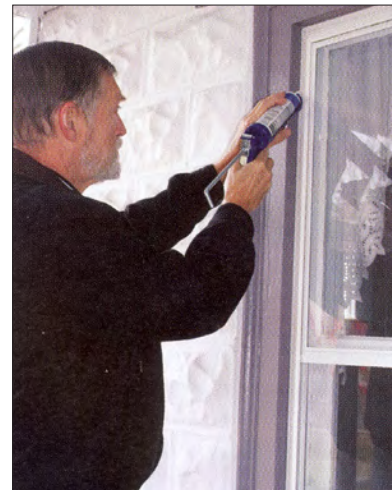
Caulking between exterior window jambs and wall surfaces is recommended to reduce air infiltration.

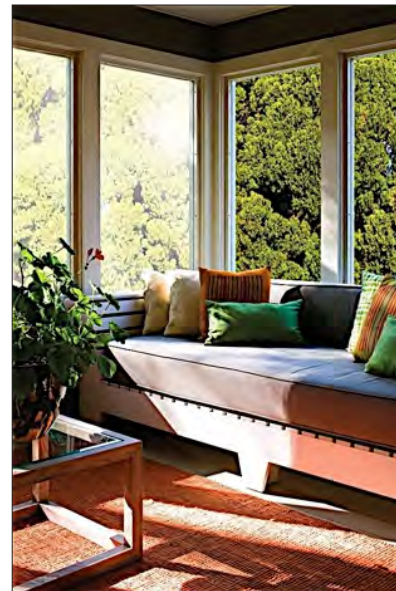
A high-quality window film has been applied to the windows on the right, while the windows on the left are unchanged. The film reduces glare, provides substantial heat rejection, and blocks harmful UV rays, protecting furniture and floors from fading.

- **Adding window films to historic glass**—applying high-quality films can be an effective means of reducing solar heat gain while still retaining the historic clear appearance of the glass (see example at right).

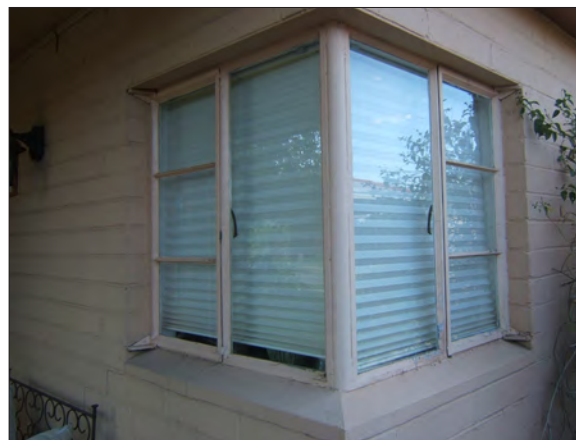
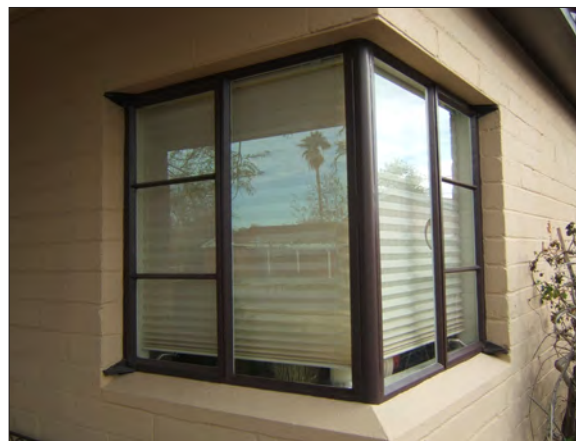
The original glass in this steel casement window (top) was replaced with single-pane hard coat Low-E glass (below).

- **Replacing historic glass with single-pane hard coat Low-E glass**—installing new hard coat Low-E glass will significantly reduce solar heat gain compared to regular single-pane glass (see example at right).

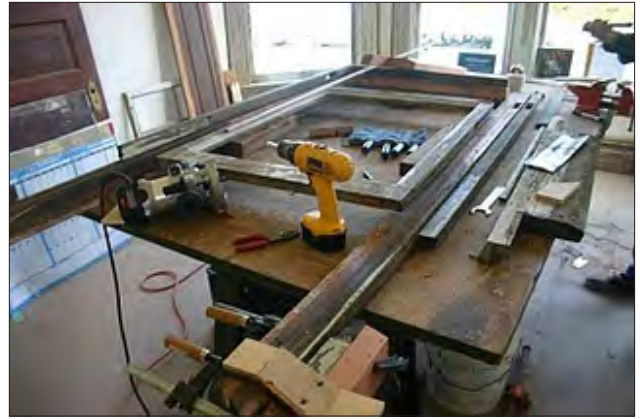
Most wood windows can be repaired. Depending on the condition of the window, it may be necessary to remove the sash and/or the affected parts of the jambs and have a carpenter or woodworking mill repair or reproduce the damaged or missing parts.

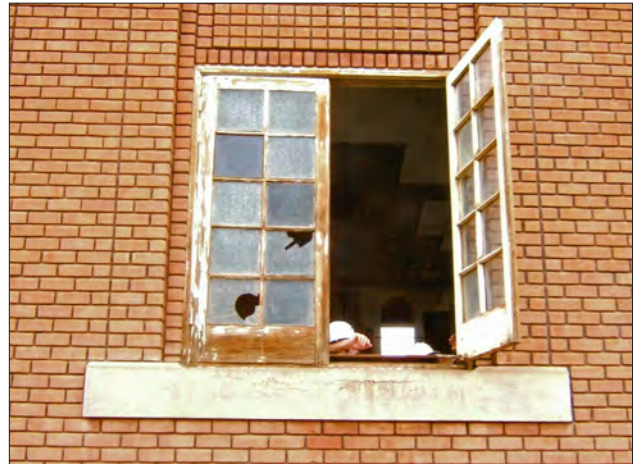
These photos show a damaged wood casement window prior to repair (top) and after a comprehensive repair was completed (bottom).

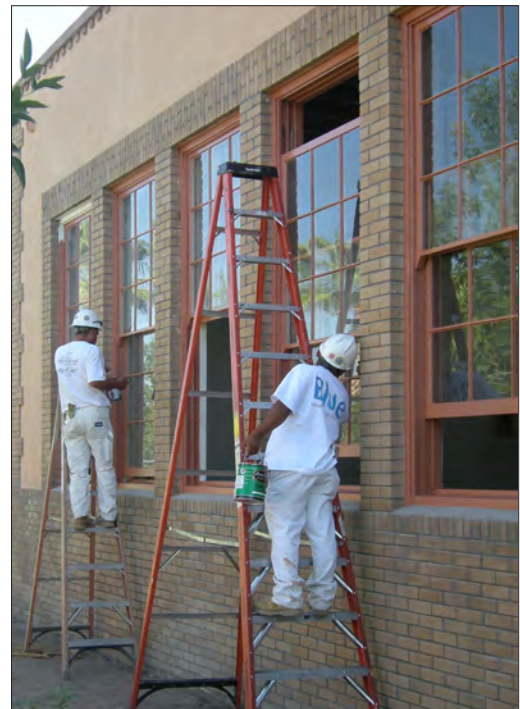
Historic wood windows at Steele Indian School Park are painted after being restored by a window repair specialist.

of the windows should be primed and painted with high-quality exterior paint or stain/sealant. If old paint layers remain, new products must be compatible and adhere tightly to earlier paint layers (which are typically oil-based). Apply paint onto glass about 1/8" to seal glazing compound.

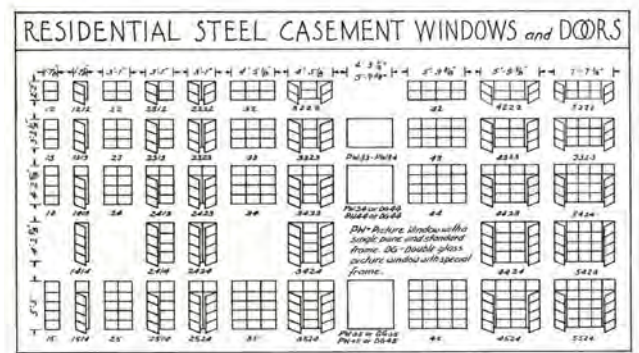
Residences during the post-World War II era used steel casement windows with many different muntin patterns, as shown in this illustration from the 1956 edition of *Architectural Graphic Standards*.

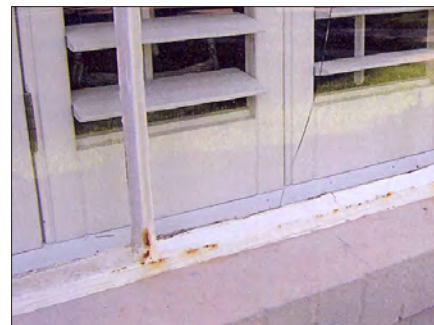
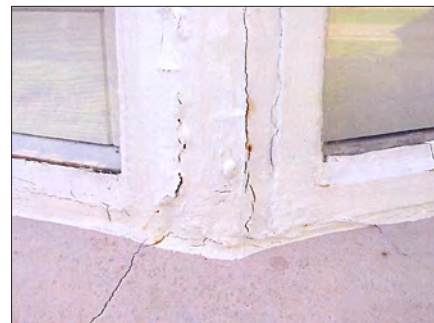
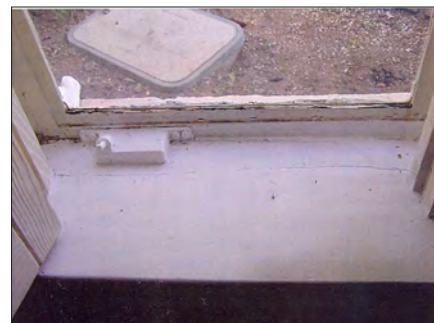
The windows shown above have problems that are common to many steel casements—peeling paint, broken glass, stuck sash, missing hardware, air infiltration, and rust.

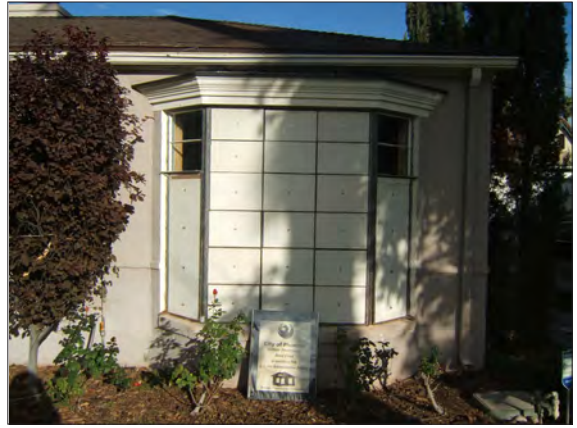
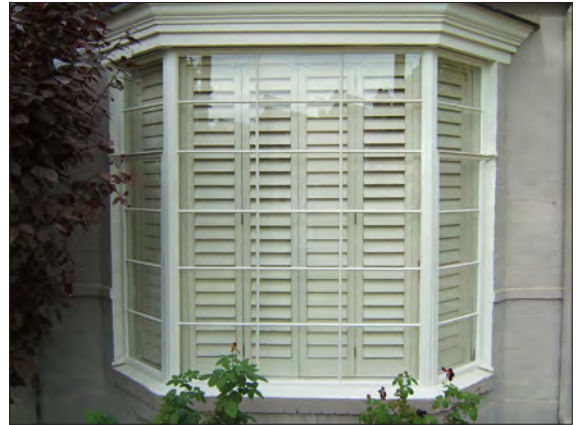
The same windows shown on the opposite page are shown again during (top) and after (bottom) repair. As part of the repair process, the windows were upgraded with 3/16" glass to increase energy efficiency and reduce noise.

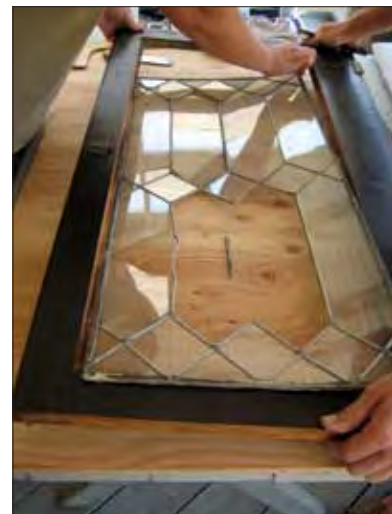
The repair of stained, leaded, or figured glass is best performed by an experienced window specialist.

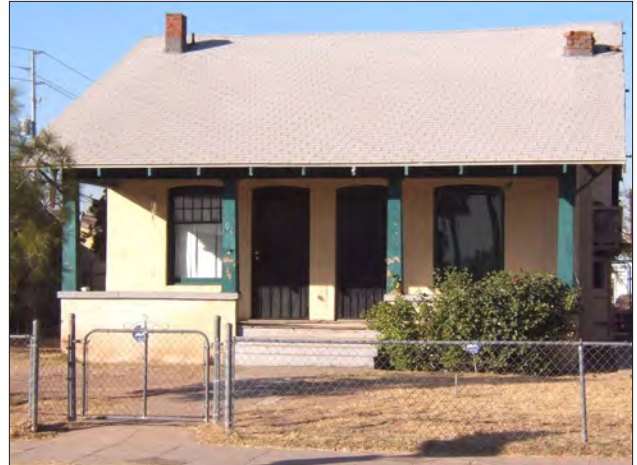
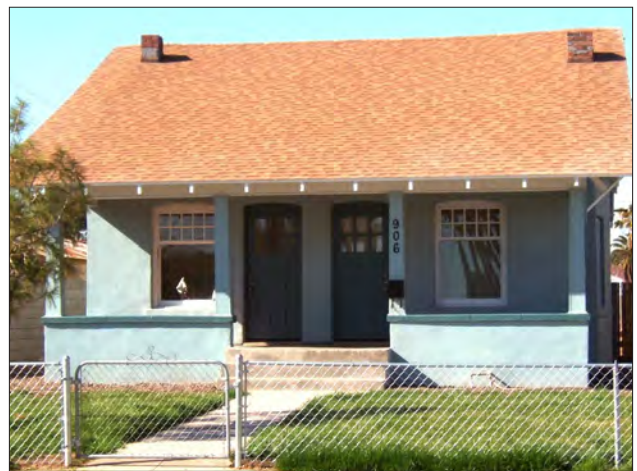
In the example above, the top photo was sufficient pictorial evidence to show that one of the front windows was nonhistoric and that its replacement (shown in bottom photo) should match the window that still remained.

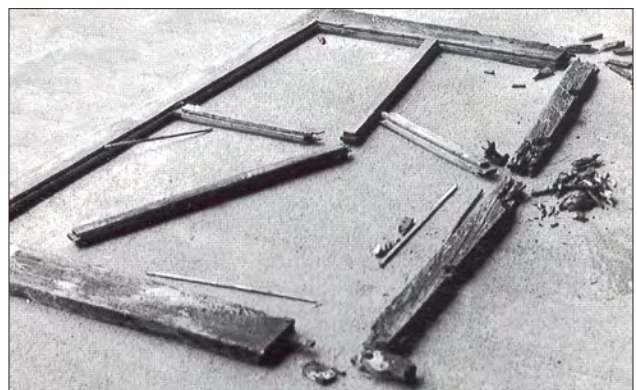
The window above is badly deteriorated and is a candidate for replacement.

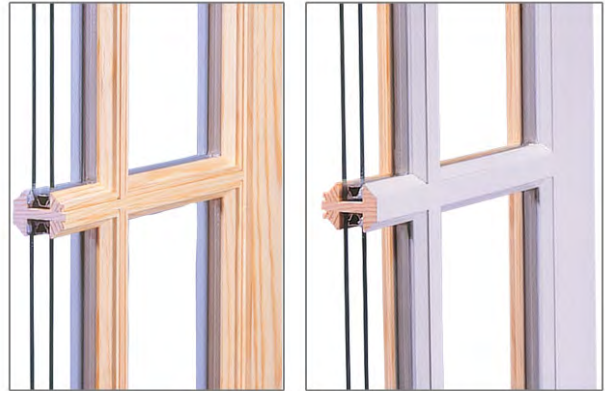
The dual-pane replacement windows shown above have true divided lights, with the muntins extending all the way through the glass. This type of window is recommended because it closely replicates the look of a historic window.

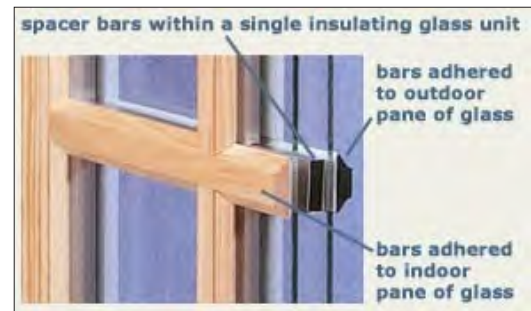
The dual-pane replacement window shown above has simulated divided lights, with muntin-like grids on the outside and inside of the glass and a spacer bar between the glass. While true divided lights are preferred, this type of window is a recommended alternative.

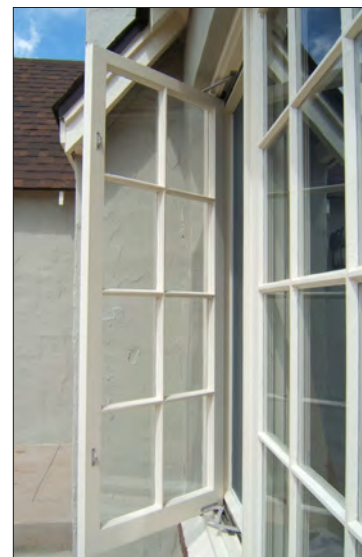
This new wood window utilized the same material as the window it replaced, as well as the same muntin pattern.

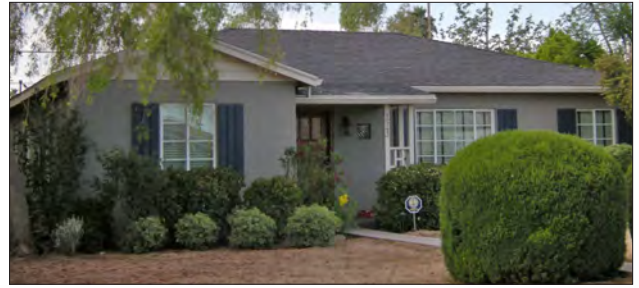
In this example, new vinyl sliders were installed in place of original steel casements. Although an alternate material was used, the work was deemed acceptable because the new windows were specially made to fit the openings. The window contractor carefully ensured that the new muntin patterns matched the originals and that the rails, stiles, and jambs of the new windows matched those of the historic windows.

alternate material (i.e., vinyl or composite) that resembles the historic material and allows the other aspects of compatibility to be met (see example at top right).

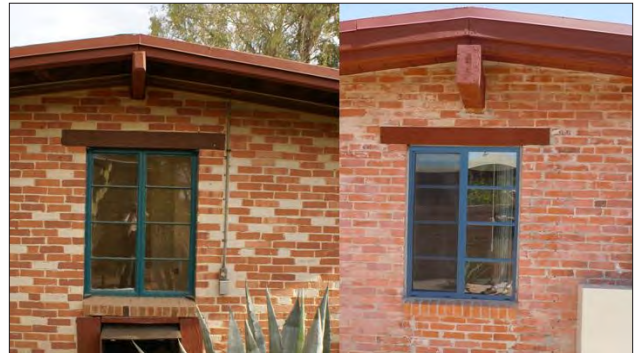
In this example, an original steel casement window (left) was replaced with an aluminum slider (right). Although the method of operation was different, the work was deemed acceptable because the material was highly compatible and the new sashes were the same size as the originals. The new muntin pattern matched that of the historic window, and the rails, stiles, and jambs also matched.

11. If the new windows must have a different method of operation, **DO** install new windows with sashes that are the same size as those on the historic windows (i.e., paired casements may be replaced by sliders if the sash size is the same; see example at middle right).

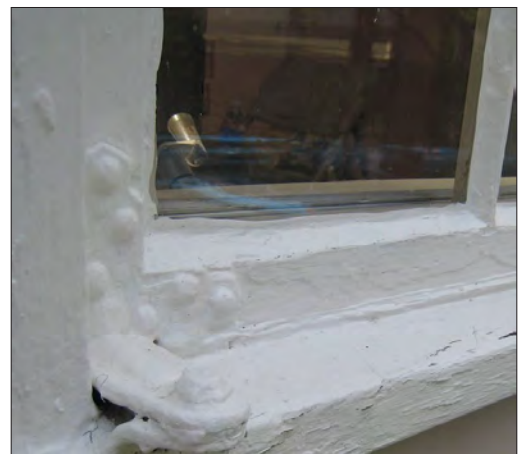
Even though this steel casement window is painted shut, the paint could be removed and the window repaired.

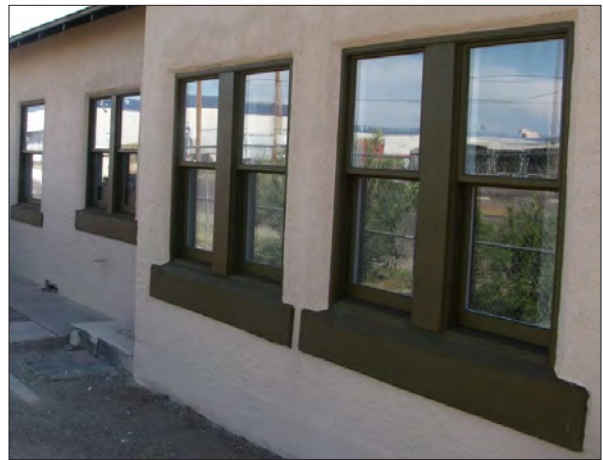
The replacement windows shown above illustrate the type of work that meets the "Recommended" requirements for both Tier 1 and Tier 2 windows.

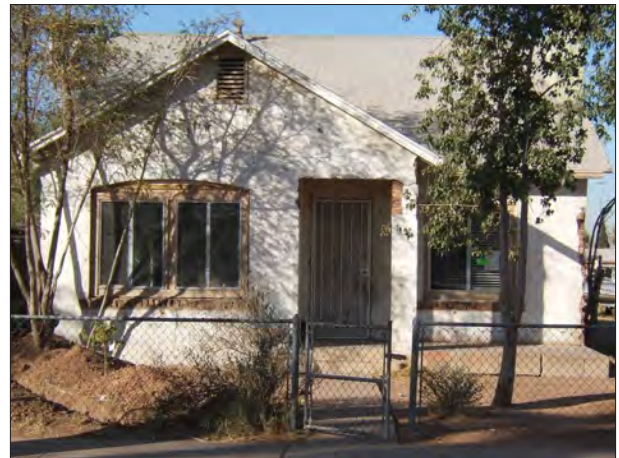
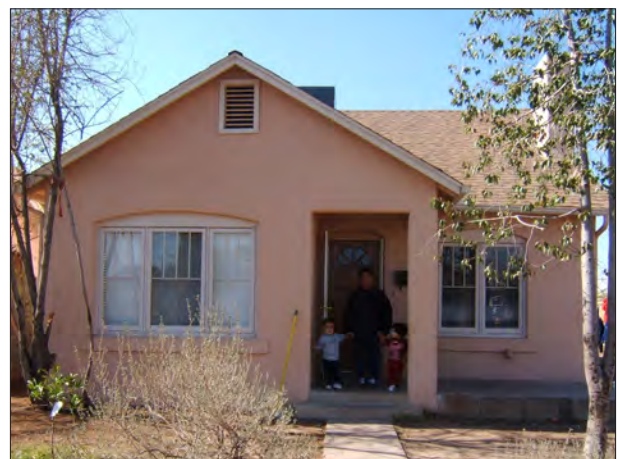
The original wood windows on this house had been replaced with incompatible aluminum sliders, with the openings reduced in size. Fortunately, there was sufficient documentation to replicate the original windows and restore the house back to its historic appearance.

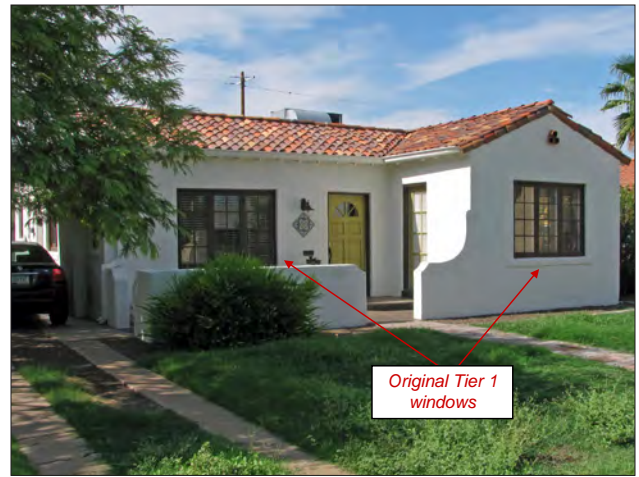
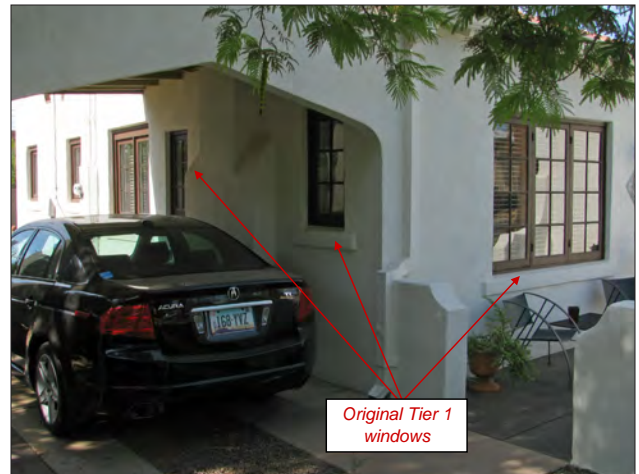
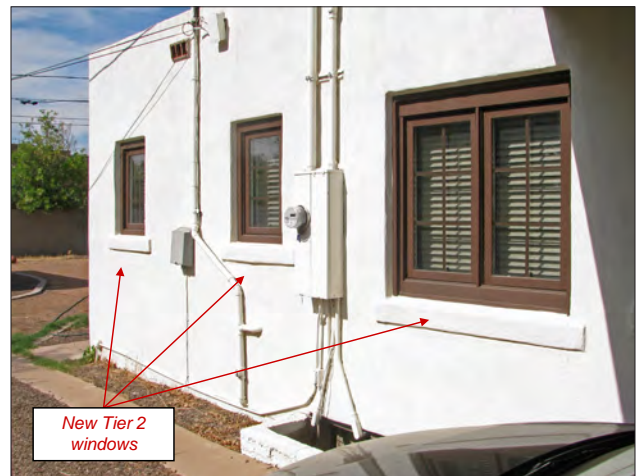
In the example above, the historic Tier 1 windows on the front of the house and on either side of the chimney were retained and repaired. The street-visible Tier 2 windows on the side of the house adjacent to the driveway were replaced with new windows with simulated divided lights, utilizing muntins with internal grids only. While these muntins are not recommended for Tier 1 windows, they may be allowed on Tier 2 windows, even if the windows are street-visible.

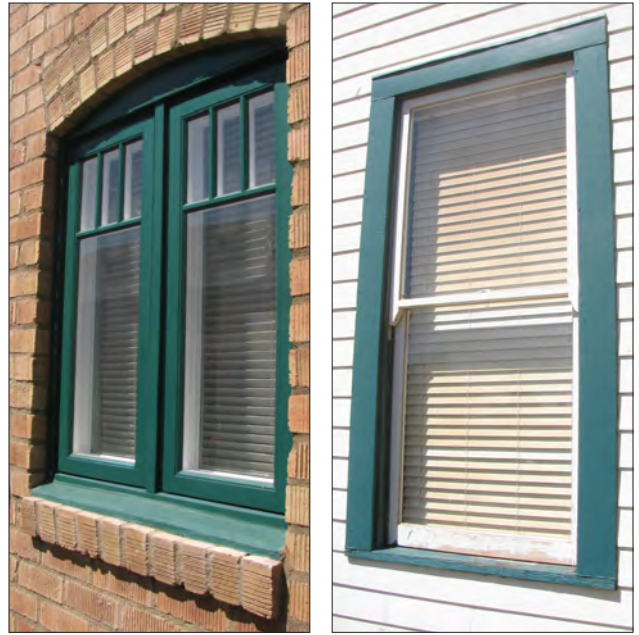
Windows in historic masonry buildings are typically recessed within the openings (see example above left). Any new replacement windows installed in these buildings should be recessed to match the historic windows. Many masonry buildings also have projecting sills at the bottom of the openings and decorative lintels at the top of the openings; these features should not be altered. Windows in wood frame buildings, on the other hand, are often flush with the exterior wall, with ornamental trim or surrounds around the outside of the openings (see example above right). New replacement windows in these buildings should be installed in the same manner, preserving the historic surrounds or trim, where possible.
